British Rail

SUPPLEMENTARY NOTICE

SIGNALLING ALTERATIONS

**DURHAM NORTH AND
RELLY MILL**

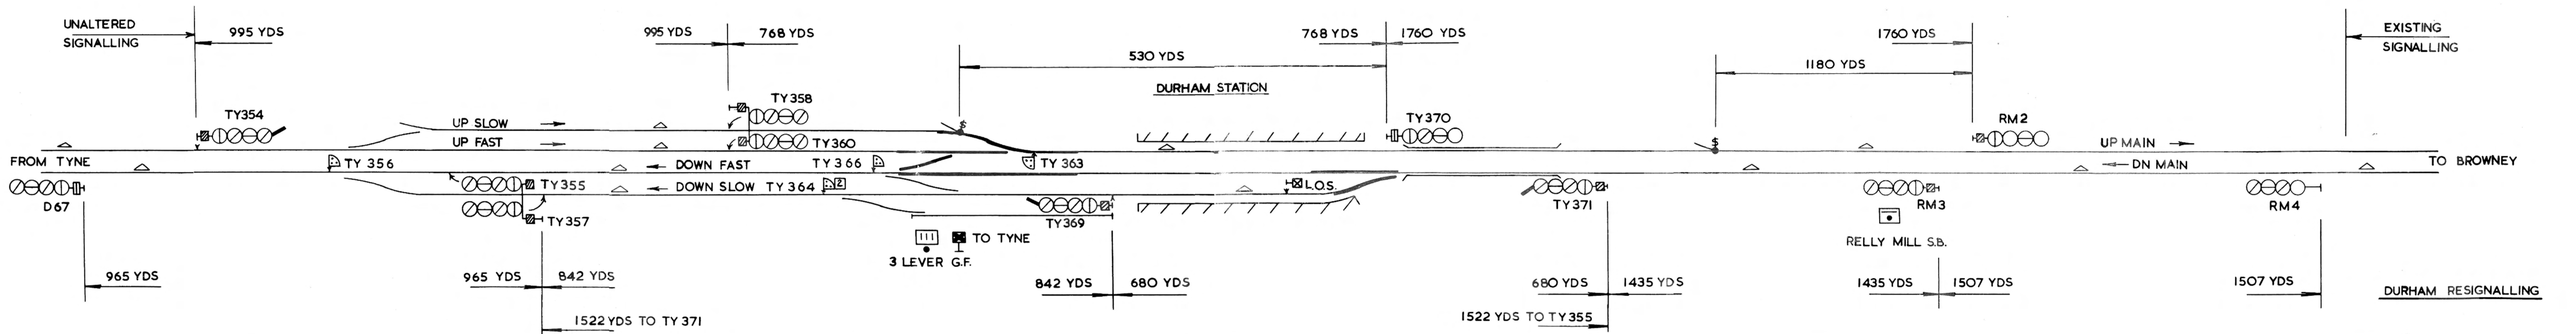
Between 07 30 hours Saturday 22 November and 18 00 hours Monday 24 November, Durham North and Durham South signal boxes will be abolished. The existing semaphore signalling between Durham South and Relly Mill will be replaced by colour light signalling with full track circuiting. Certain existing colour light signals will be altered in form, repositioned and re-numbered. The new signalling will be controlled by Tyne and Relly Mill signal boxes, and the Track Circuit Block Regulations will apply between these signal boxes.

The theatre type route indicator on the Down Main 4-aspect colour light signal DS51 will be replaced by a junction indicator Position 1, and the associated subsidiary signal will be abolished. The signal will be re-numbered TY371.

The existing 2 lever ground frame will be replaced by a 3 lever ground frame in the same position. The additional lever will control the operation of new subsidiary signal TY364 with route indication "S" which applies Down Slow to Down Siding.
