THE SIGNALLING RECORD THE JOURNAL OF THE SIGNALLING RECORD SOCIETY

No. 193

Spring 2019

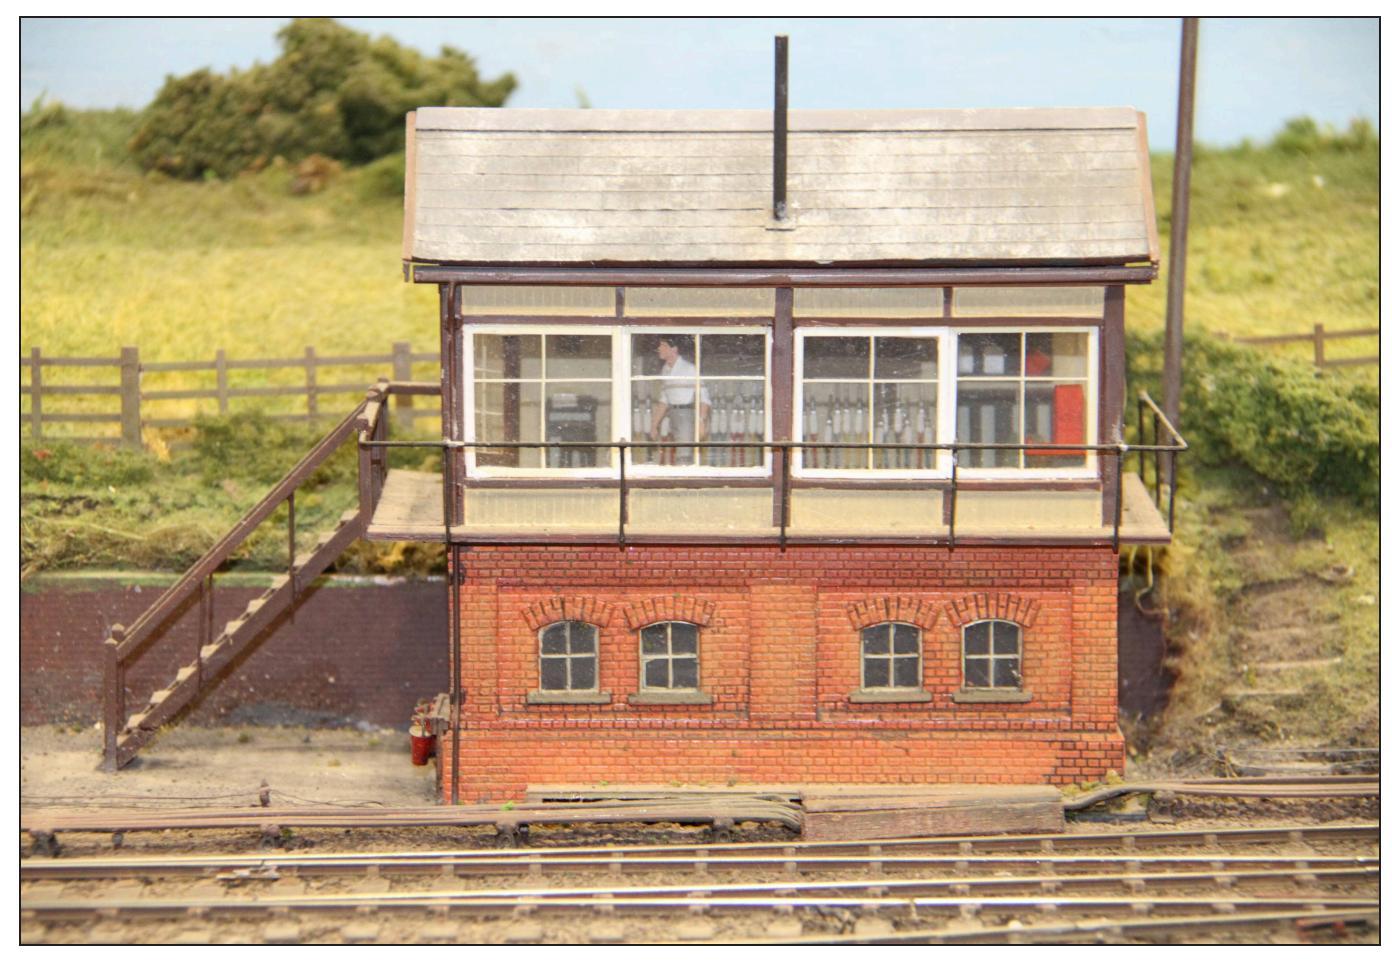
This close up view of the Junction signal box, reveals a signalman at work, levers and a key token machine. The attention to detail extends to notices in clip boards at the back of the signal box.

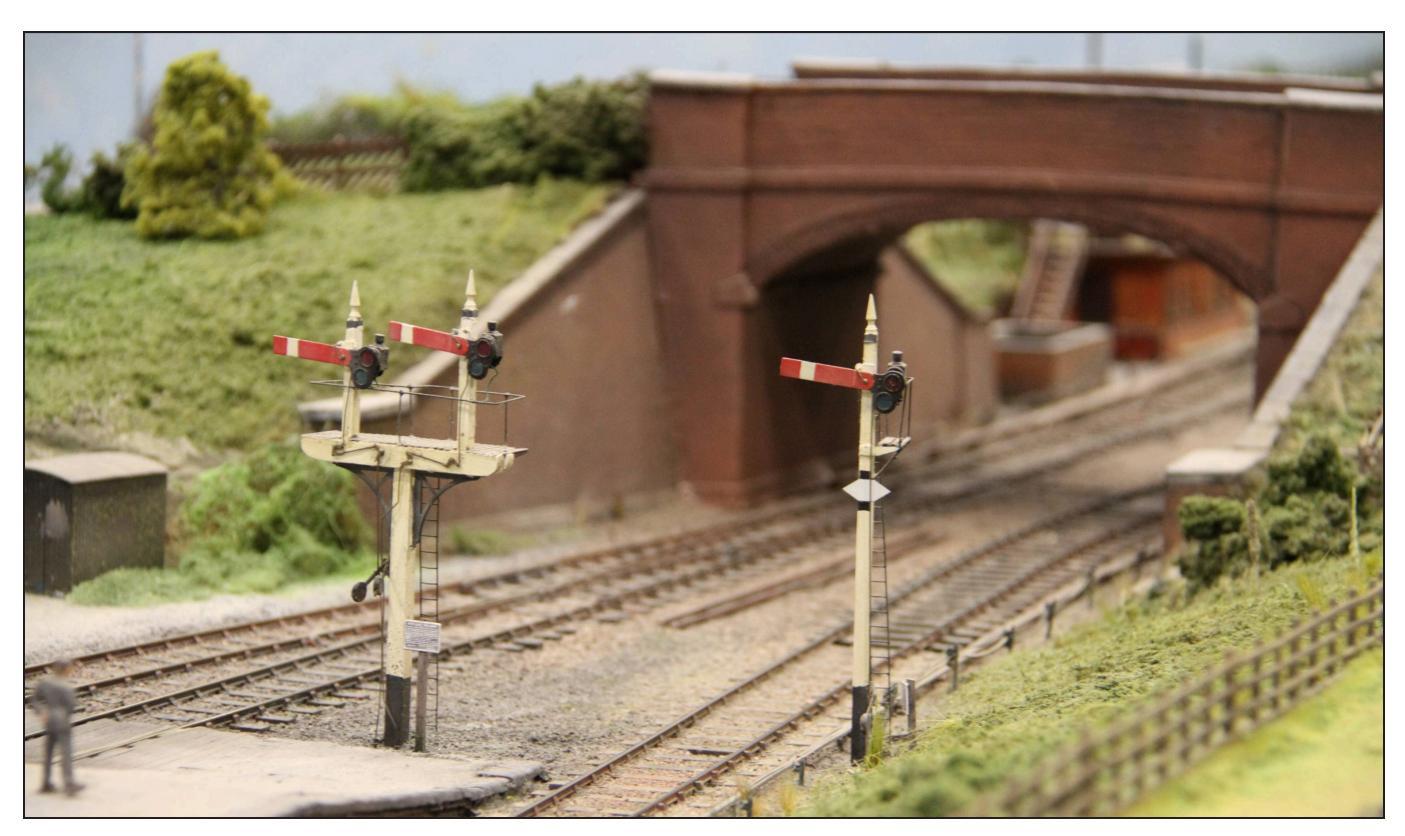
The southbound platform starting signals at Broom station with the road overbridge and junction signal box in the background. These lovely models of the Midland Railway signals include a lot of fine detail which has been carefully modelled. On quite a lot of lower quadrant signals, towards the ends of their lives, the arms stood slightly above horizontal when at danger due to wear on the arms and arm stops. New signals were provided here in 1942 to incorporate signalling changes and new distant signals in connection with the new East and West boxes.

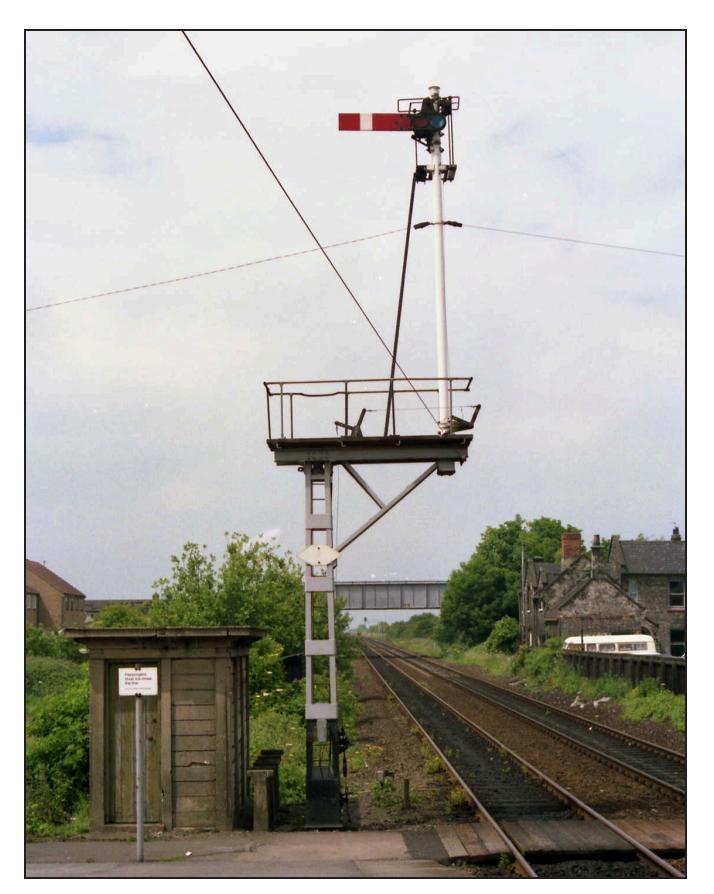
Brough East Up Main Starter bracket, 10th June 1989. [Photo: Andrew K Overton]

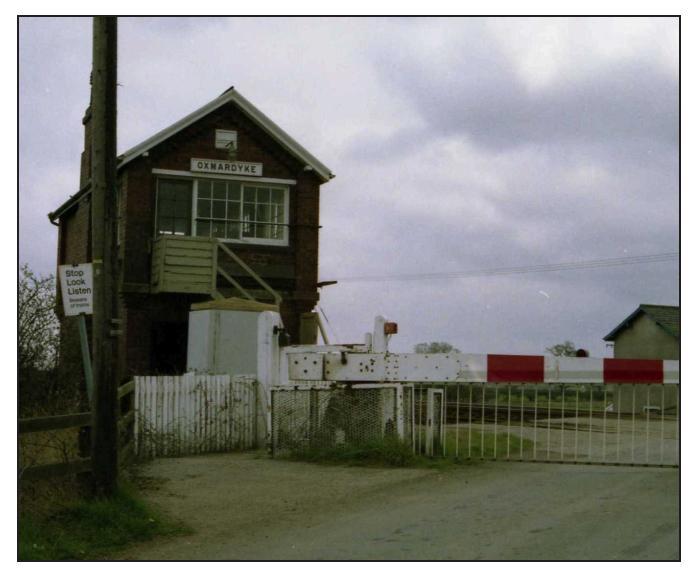
Oxmardyke GB with wheel operated barriers 6th April 1988. [Photo: Andrew K Overton]

Oxmardyke GB [2:38A] - 26/11/2018 (per signalling notice). Gate box closed, McK&H 16 recon. frame decommissioned (actually 23 or 24/11/2018). Crossing converted to MCB-OD controlled by York ROC (Brough WS).

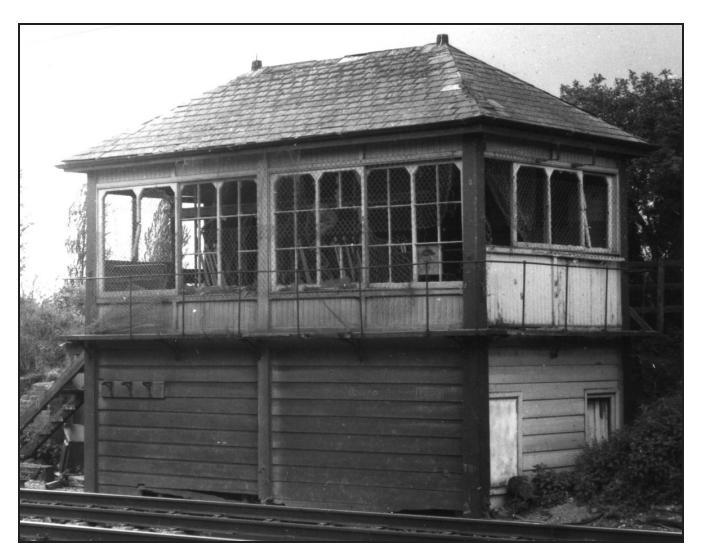
Sundon signal box photographed in May 1976, two years after its closure in July 1974, hence its derelict condition. Of note are the missing finial tops. [Photo: Mike Christensen]

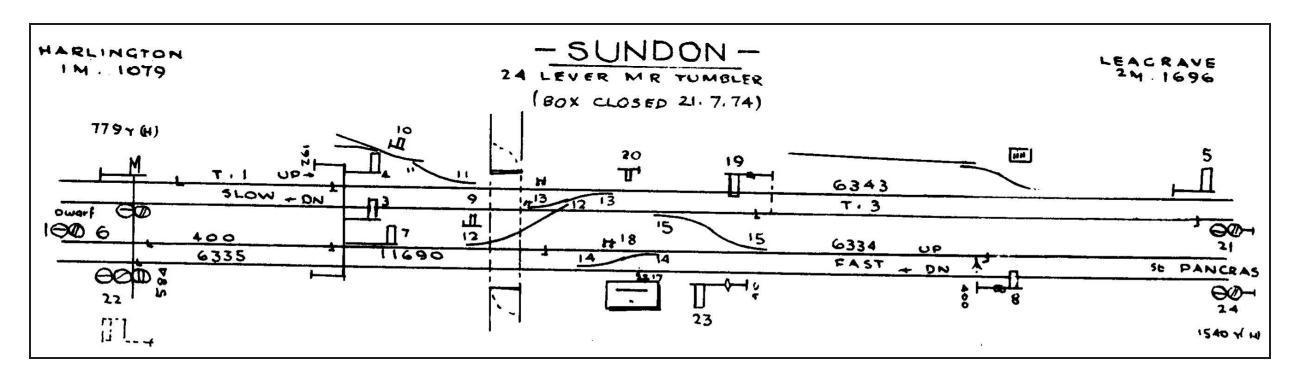
[Diagram: John Swift Collection]

Signalling diagram for Sundon signal box. The siding and its controlling ground frame, believed to be Inn's Siding, is shown at the right hand end of the diagram with the siding connection trailing into the up slow.

John Swift's signalling diagram for Sundon shows another siding to the south of the box, which presumably was Inn's Siding, according to the Sectional Appendix, but I stand to be corrected on this.

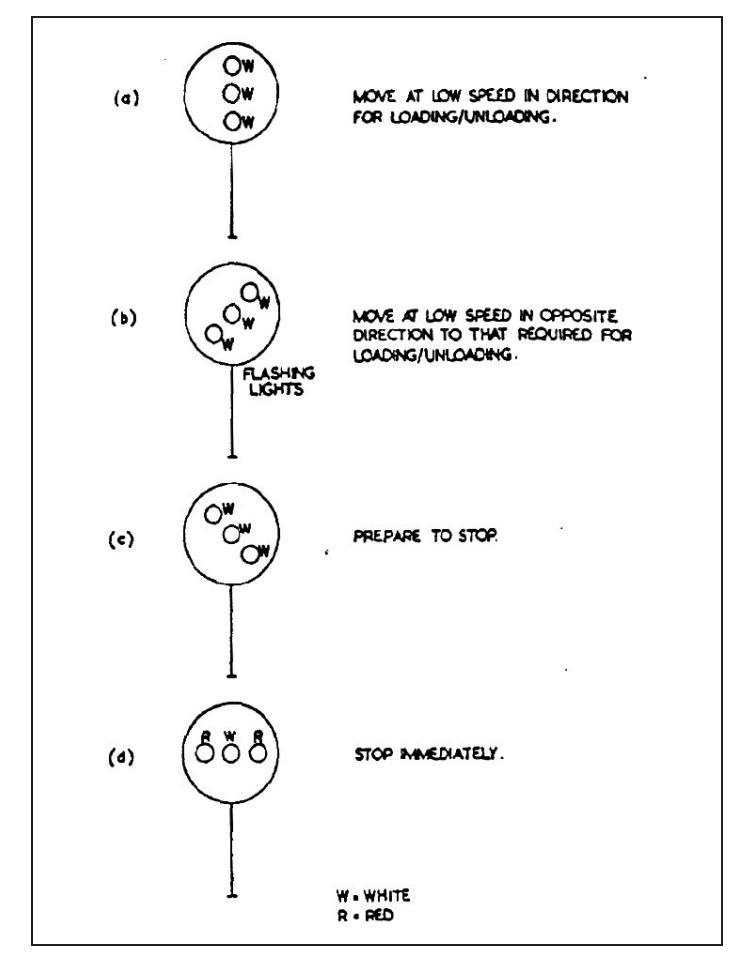
Where considered necessary control of movements over sidings where continuous or static loading takes place, where the train is worked throughout by British Railways locomotives, shall be by position light (3 lamp) signals displaying aspects in accordance with Appendix A. (*Diagram shown opposite.*)

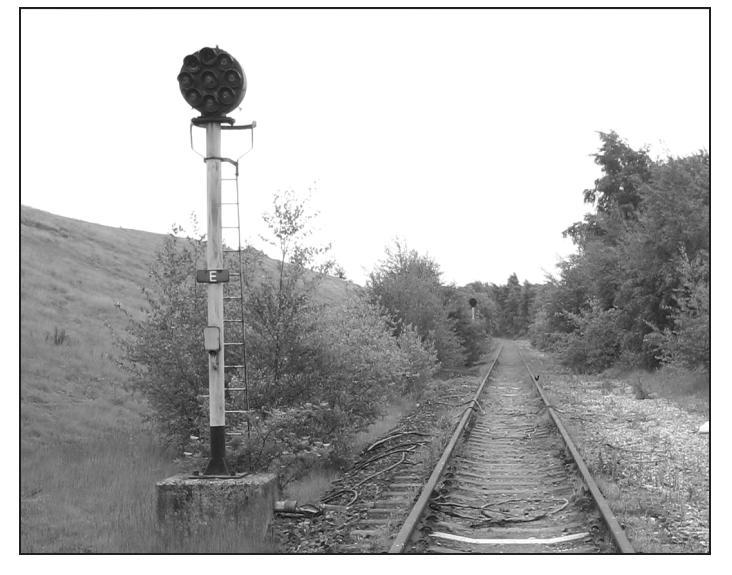
Toton signal E for MGR loading operations at Harworth Colliery, controlled by both Harworth Colliery Bunker No.1 Panel and No.2 Panel, 27th May 2009. [Photo: Andrew K Overton]

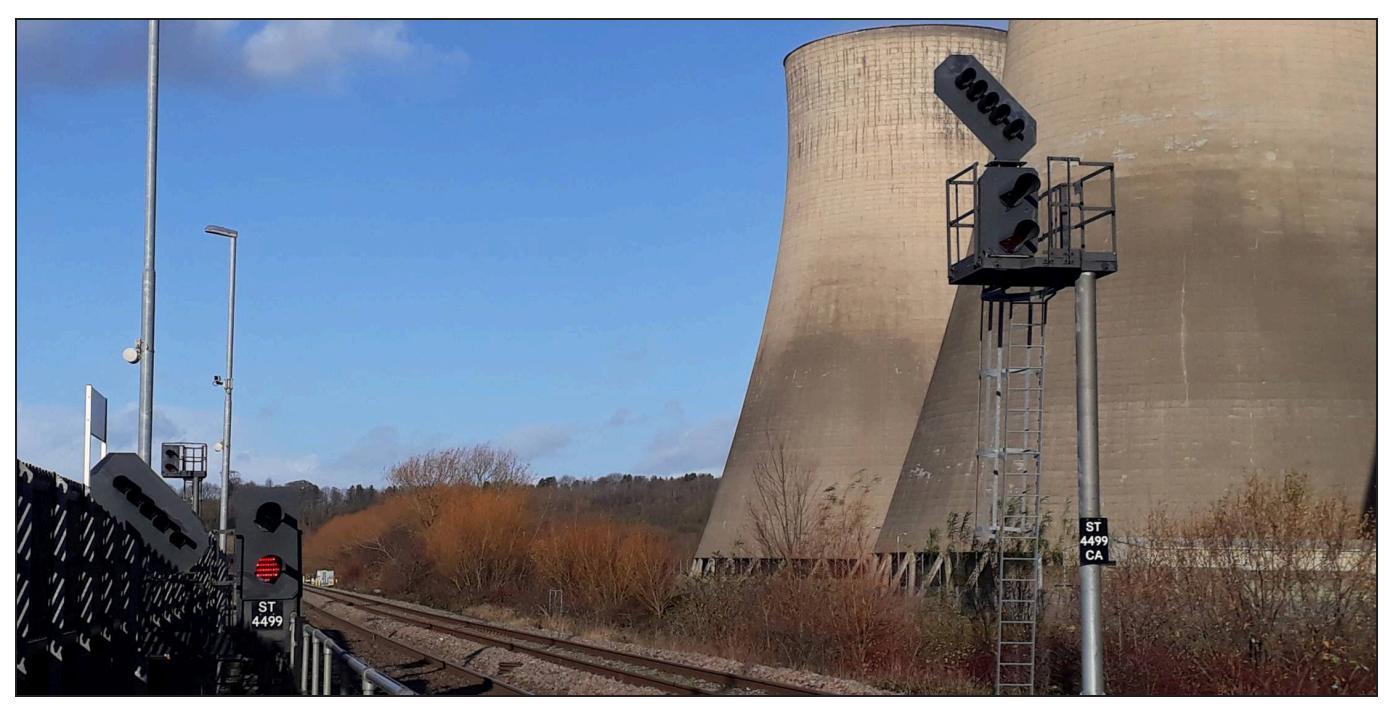
Co-acting platform starting signals on the down slow line at East Midlands Parkway. The right hand signal, which is to the far side of the adjacent line, has the appropriate 'CA' suffix. Also of interest is the no. 1 position PLJI that is mounted to the side of the main signal, which in turn is on the ground, to enable it to be visible under the station canopy.

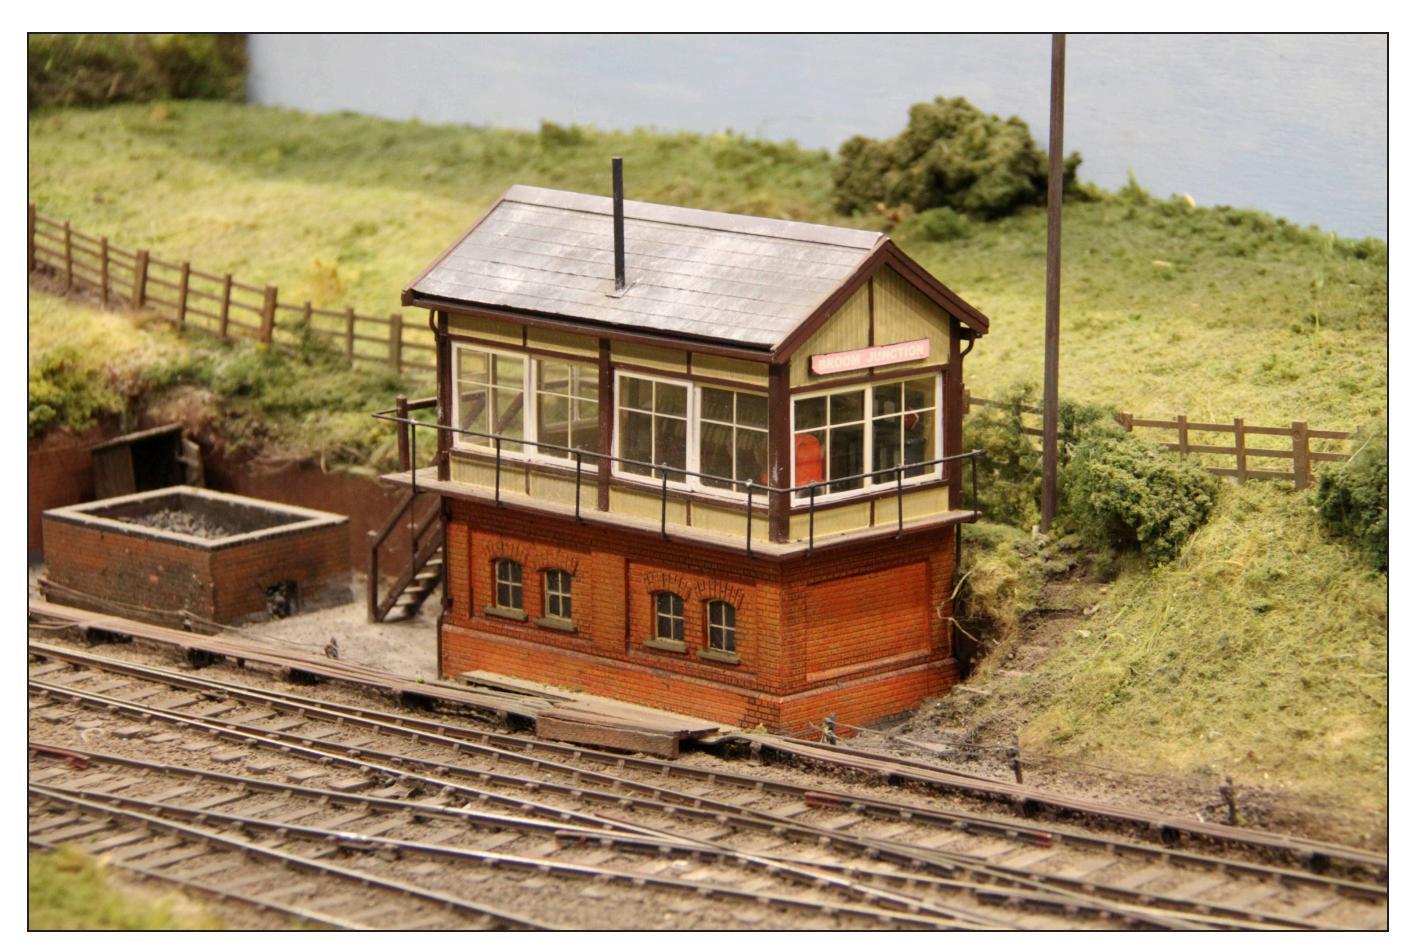
The Society's Award for the best signalled layout at the Warley Model Railway Exhibition went to the Warley club's layout, Broom Junction, which is intended to portray the station and junction as it was in the middle 1930s. It was built by the club many years ago and has undergone a number of rebuildings and improvements since. However it is understood that this was to be its last outing. This photograph shows the model of Broom Junction signal box. This LMS Type 11c box was opened on 6th May 1934 to replace the old Midland North and South boxes, and was renamed Broom North in 1942 when a new south to east curve was opened with new boxes at Broom East and West. Note the attention to detail on this 7mm to the foot (O Gauge) model with the signal wires and point rodding carefully modelled.

The winner this year was the Warley Model Railway Club (yes, the organisers of the whole exhibition) with its layout of Broom Junction. Broom Junction was one of the places where the Stratford & Midland Junction Railway met the Midland Railway, in this case at the western end of the S&MJR on the Midland's Redditch – Evesham – Ashchurch line, a location with a slightly unusual layout. The model illustrated the correct detail of MR signalling at the location as well as the overall atmosphere, and greatly impressed the judges.
